AERONAUTICAL ENGINE LABORATORY

NAMC-AEL-1674 8 FEB 1961

HIGH STRENGTH REFRACTORY ALLOYS

PHASE A REPORT ON
BUWEPs P. A. NAM-RAPP33001

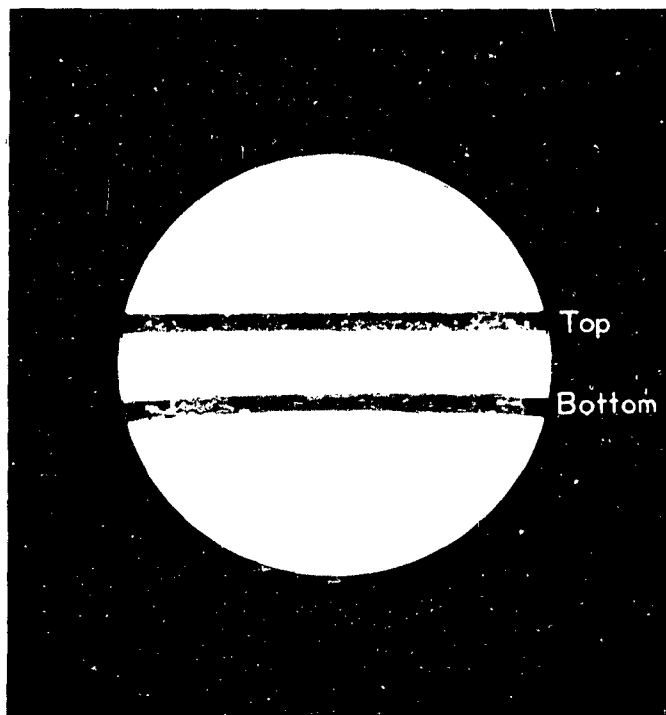
PLATE 5

c. In tests numbered 1, 2, 3, and 8, both the zinc coated columbium and the zinc coated columbium plus 2% zirconium were exposed to exhaust gases from the combustion of hydrogen and air. Both materials failed when exposed to an exhaust gas temperature of 1800°F. As can be seen on plates 5 and 6, the coating on the columbium rod had ruptured slightly, whereas several needle-like growths had developed on the surface of the columbium plus 2% zirconium rod.

RODS AFTER TEST NO. 8 UPSTREAM

Top Rod --- Zinc Coated Columbium
Bottom Rod -- Zinc Coated Columbium
Plus 2% Zirconium

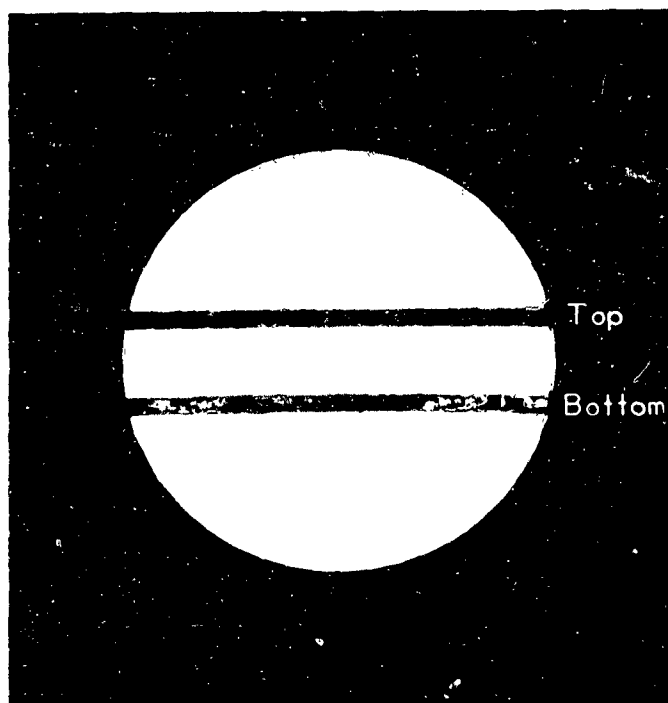
PLATE 6

RODS AFTER TEST NO. 8 DOWNSTREAM

Top Rod ---- Zinc Coated Columbium
Bottom Rod --- Zinc Coated Columbium
Plus 2% Zirconium
